## Technical Note TN4

### G Series video output PCB replacement

This document applies to all versions of G91, G92, G95, G96 and G98.

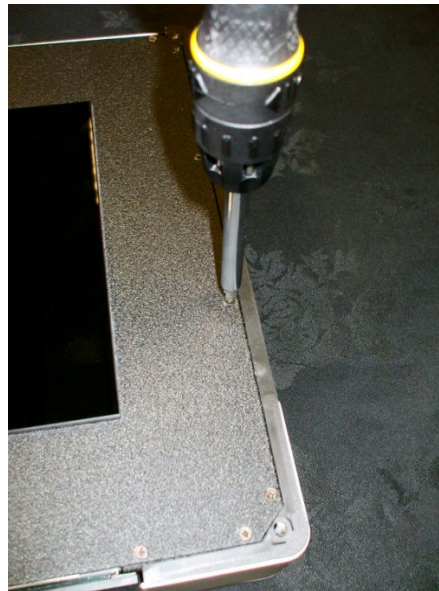
1. Remove the four 3mm Allen screws securing the outer top-cover and remove it. Then remove the 12 cross-head screws to allow the the inner top-cover to be removed.
